**NONDESTRUCTIVE ANALYSIS OF  
SALES GAS LINE PIPE EVIDENCE  
FROM THE WEST COTE BLANCHE  
BAY PIPELINE RUPTURE INCIDENT**

**Prepared For The  
NATIONAL TRANSPORTATION  
SAFETY BOARD  
Washington, DC**

**FEBRUARY 27, 2007**

**PN 131454**

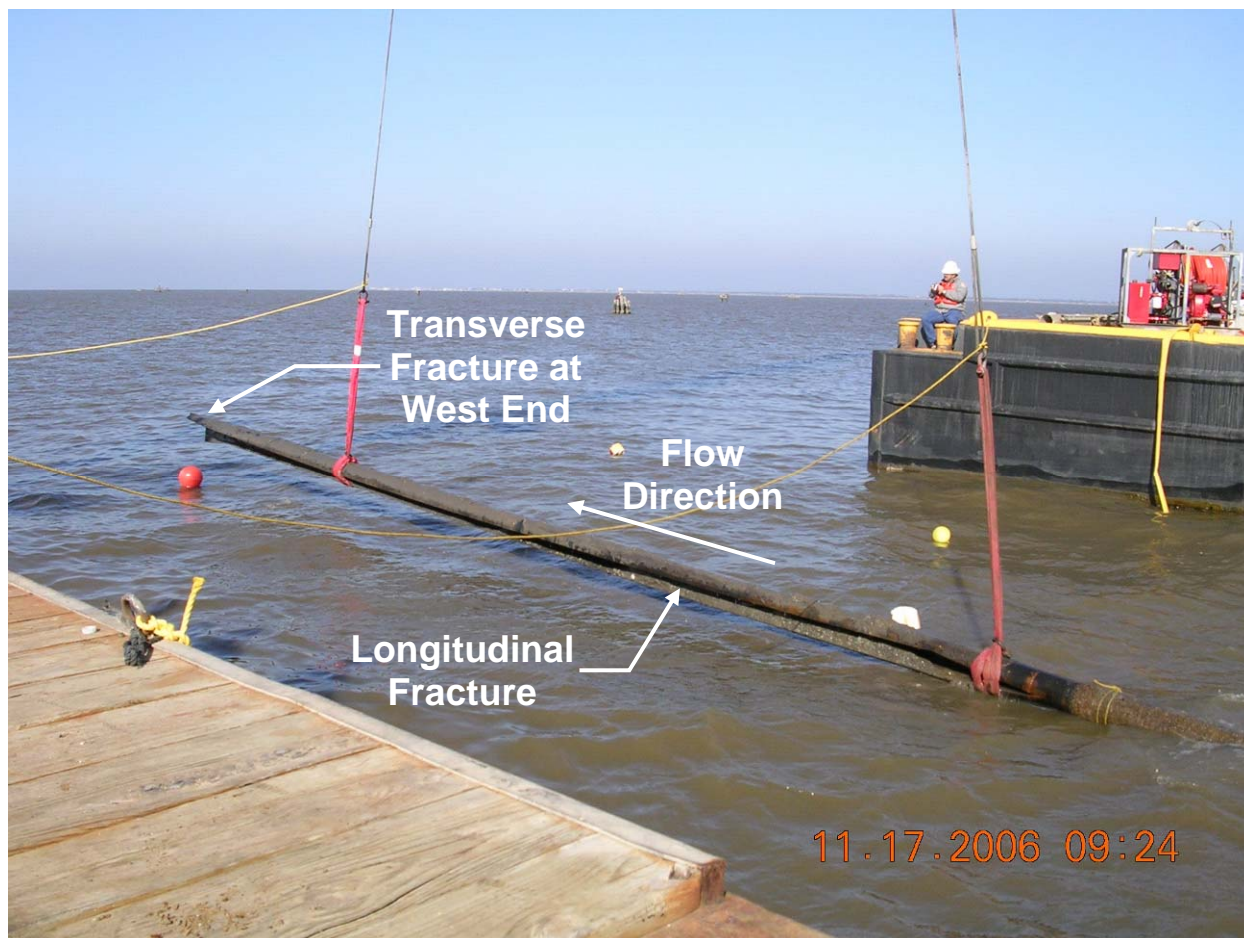
**Figure 1:** The east portion of the sales gas line as it was being salvaged. Notice the transverse and longitudinal fractures.

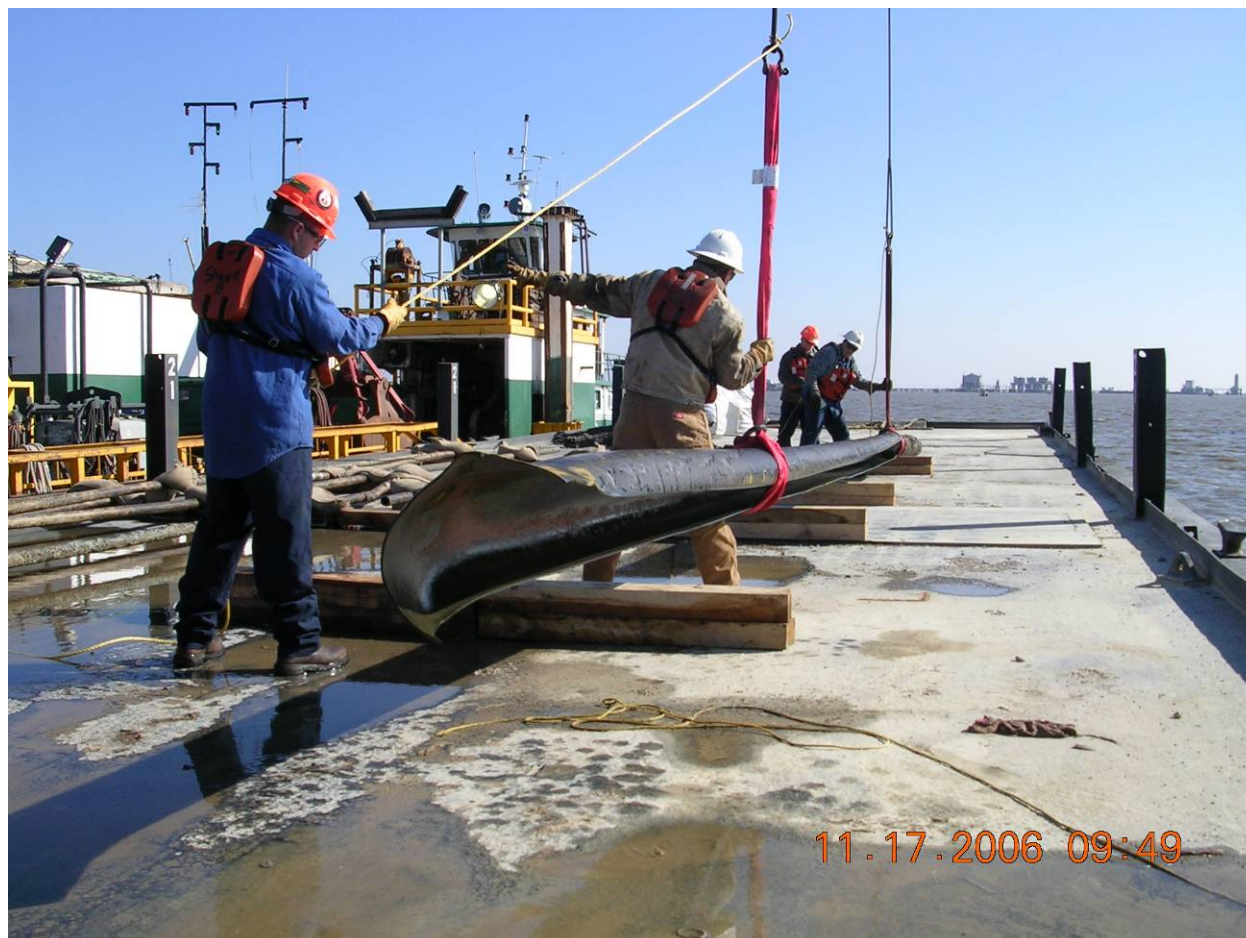
**Figure 2:** The east portion of the sales gas line during salvaging as viewed from the transverse-fractured, west end.

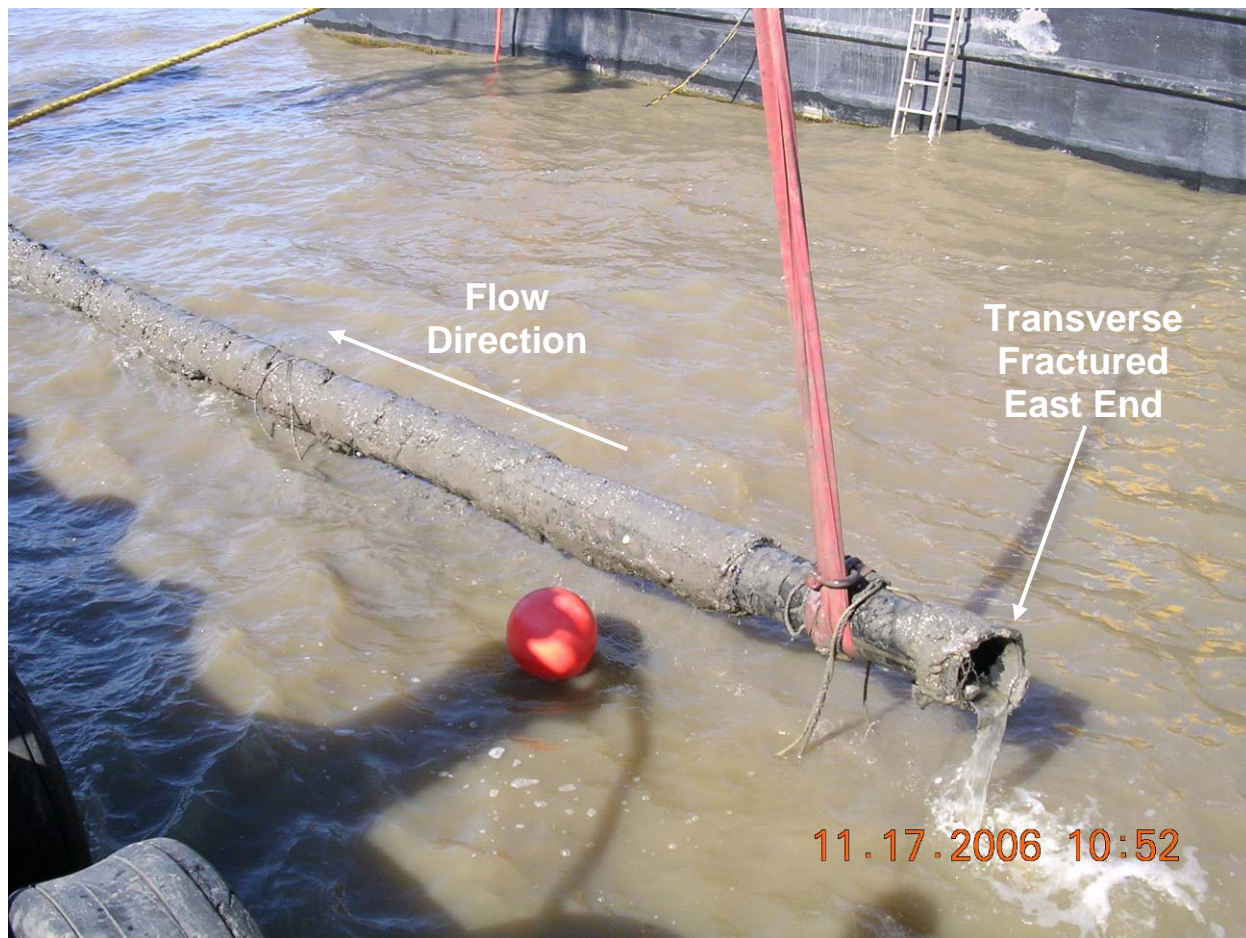
**Figure 3:** The fractured east end of the west portion of the sales gas line during salvaging. Notice the location of the transverse fracture.

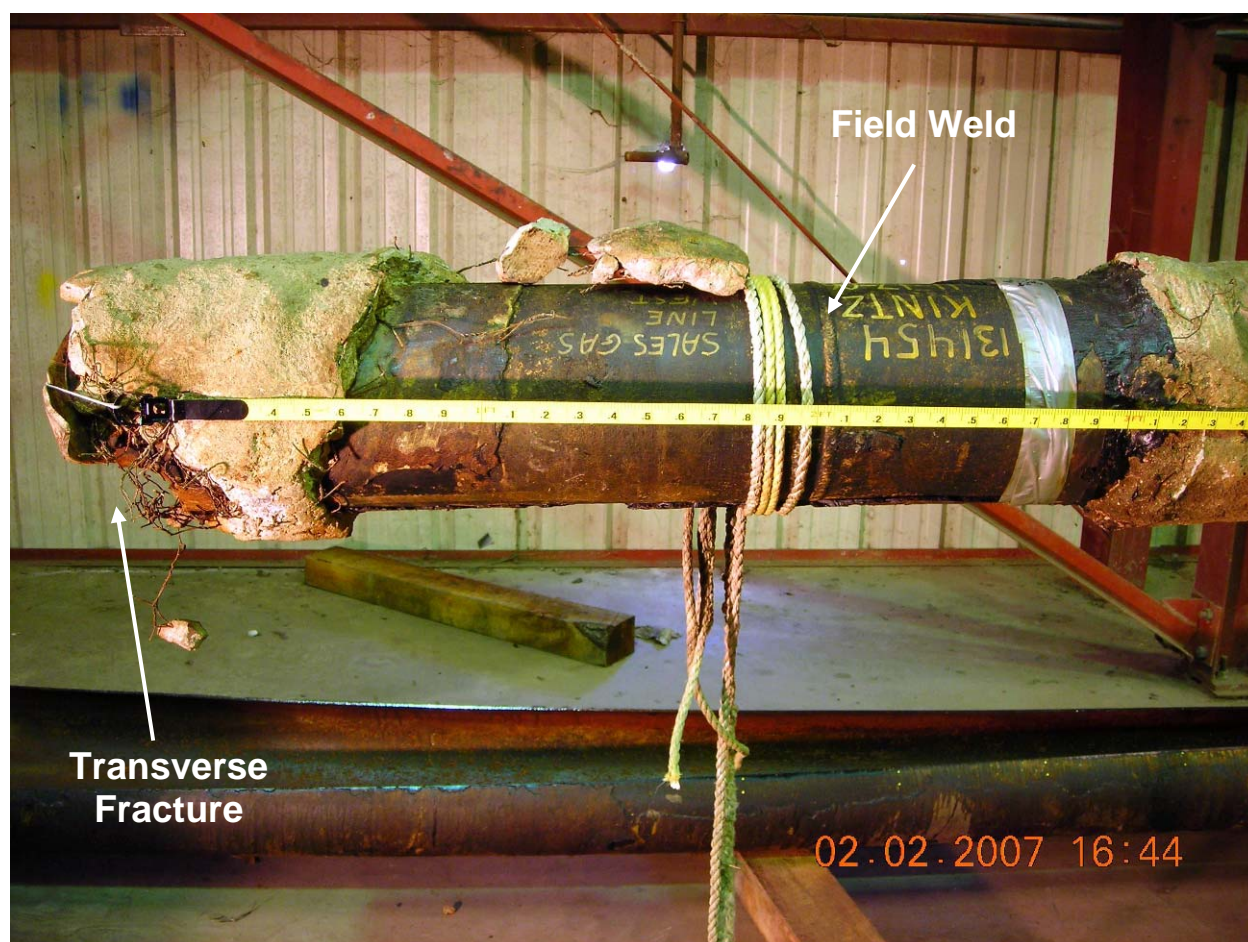
The rupture event produced both a transverse fracture and a longitudinal fracture in the pipe. The transverse fracture was located approximately 2.1 feet east of a circumferential field girth weld located in the west portion (Figure 6). The longitudinal fracture extended from the transverse fracture to the east for a distance of approximately 43.4 feet (Figure 7). The longitudinal fracture intersected only one field girth weld, which was located approximately 43 feet east of the transverse fracture. The longitudinal fracture did not extend to the west of the transverse fracture into the west portion of the sales gas line.

**Figure 6:** The east end of the west portion of the sales gas line showing the location of the transverse fracture, approximately 2.1 feet east of a circumferential field girth weld.

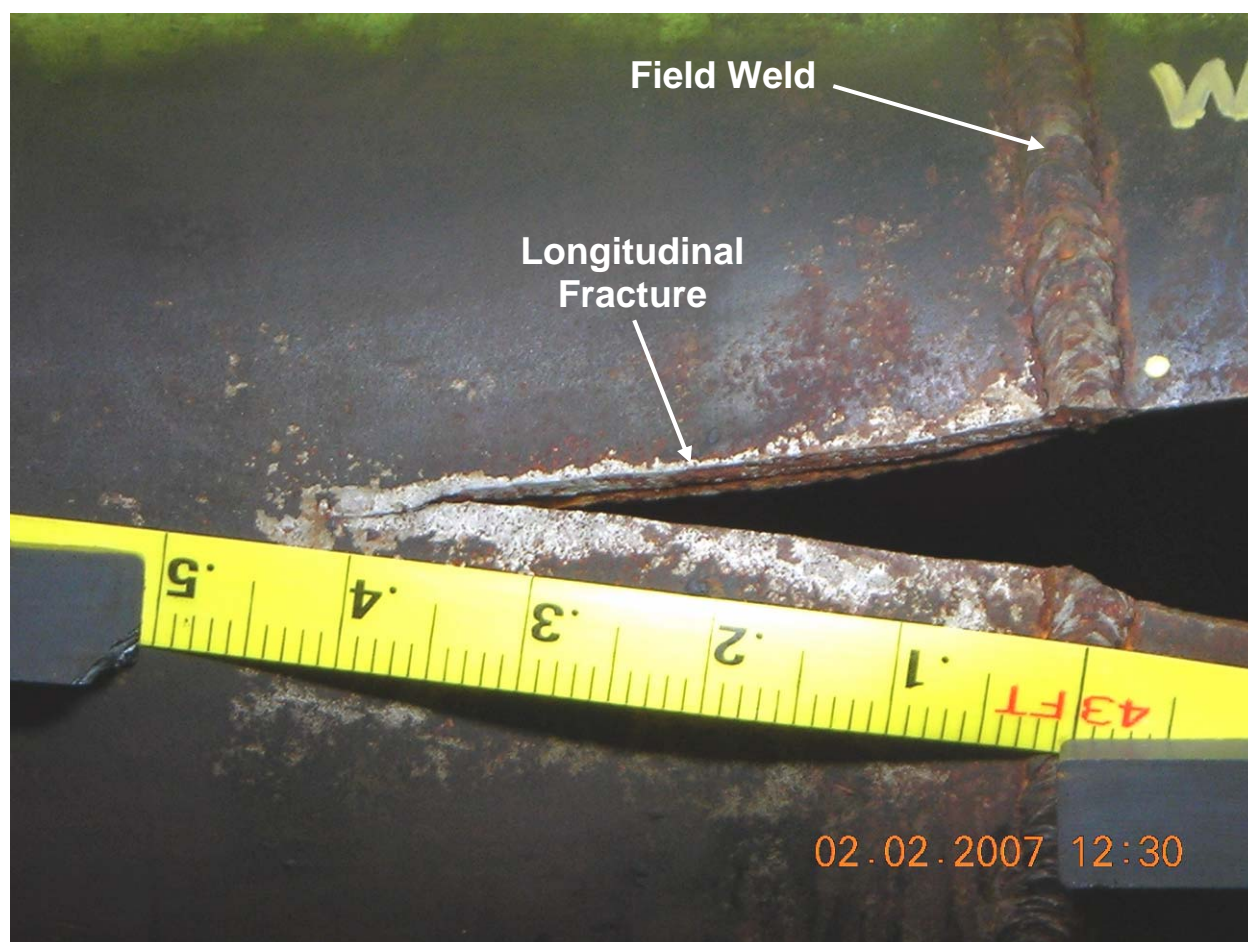
**Figure 7:** The east end of the longitudinal fracture in the east portion of the sales gas line, approximately 43.4 feet east of the transverse fracture. Notice the location of the field girth weld.

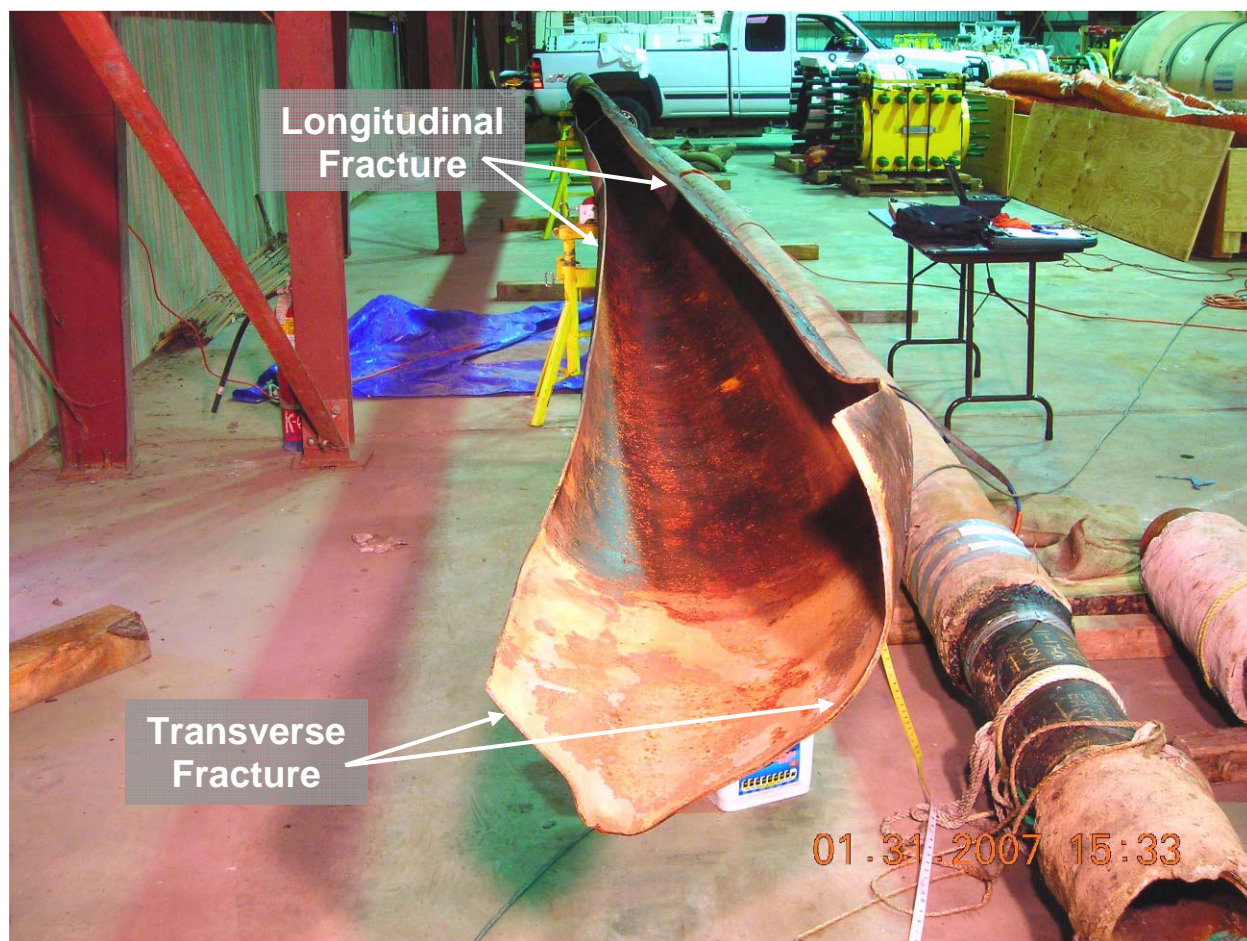
**Figure 10:** The east portion of the sales gas line rotated such that the knot indicating the geometric top of the pipe as it was discovered following the rupture was located at the bottom. Notice that the longitudinal fracture was located near the geometric bottom of the pipe as it was discovered following the rupture.

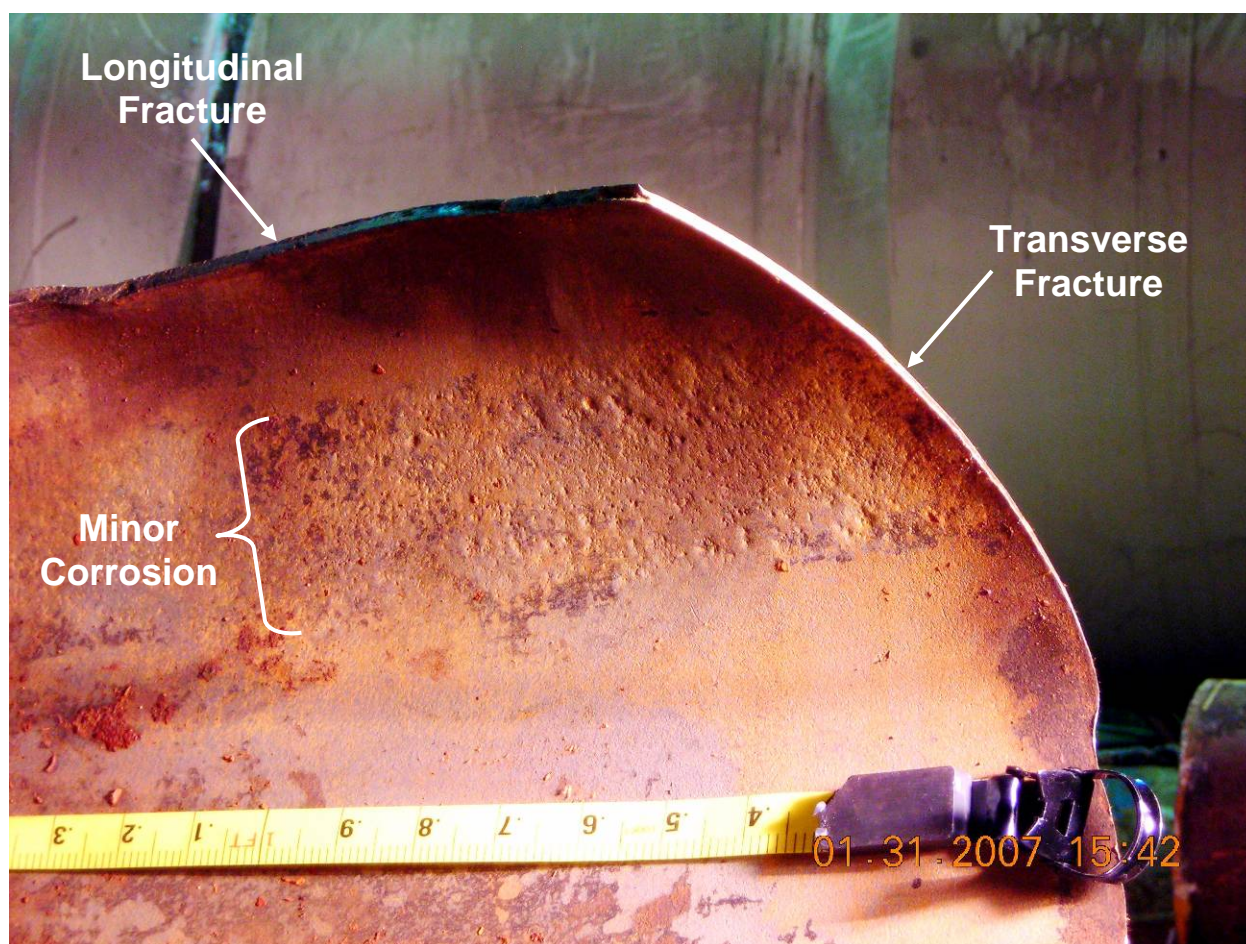
the rupture. A longitudinal band of minor corrosion was observed on the inside surface of the east portion in the vicinity of the transverse fracture (Figure 11). The minor corrosion most likely resulted from the presence of water inside the bottom of the pipe during service. The minor corrosion is the most likely indicator of the actual geometric bottom of the pipe prior to the rupture. The longitudinal fracture was located approximately 3.75 inches circumferentially from the center of the band of corrosion. If the band of minor corrosion in fact represents the geometric bottom of the pipe prior to the rupture, then the longitudinal fracture in the east portion of the sales gas line was located approximately 3.75 inches circumferentially or 50 degrees above the geometric bottom on the south side of the pipe.

**Figure 11:** A longitudinal band of minor corrosion pitting on the inside surface of the east portion adjacent to the transverse fracture. Notice that the longitudinal fracture is located outside of the band of pitting.

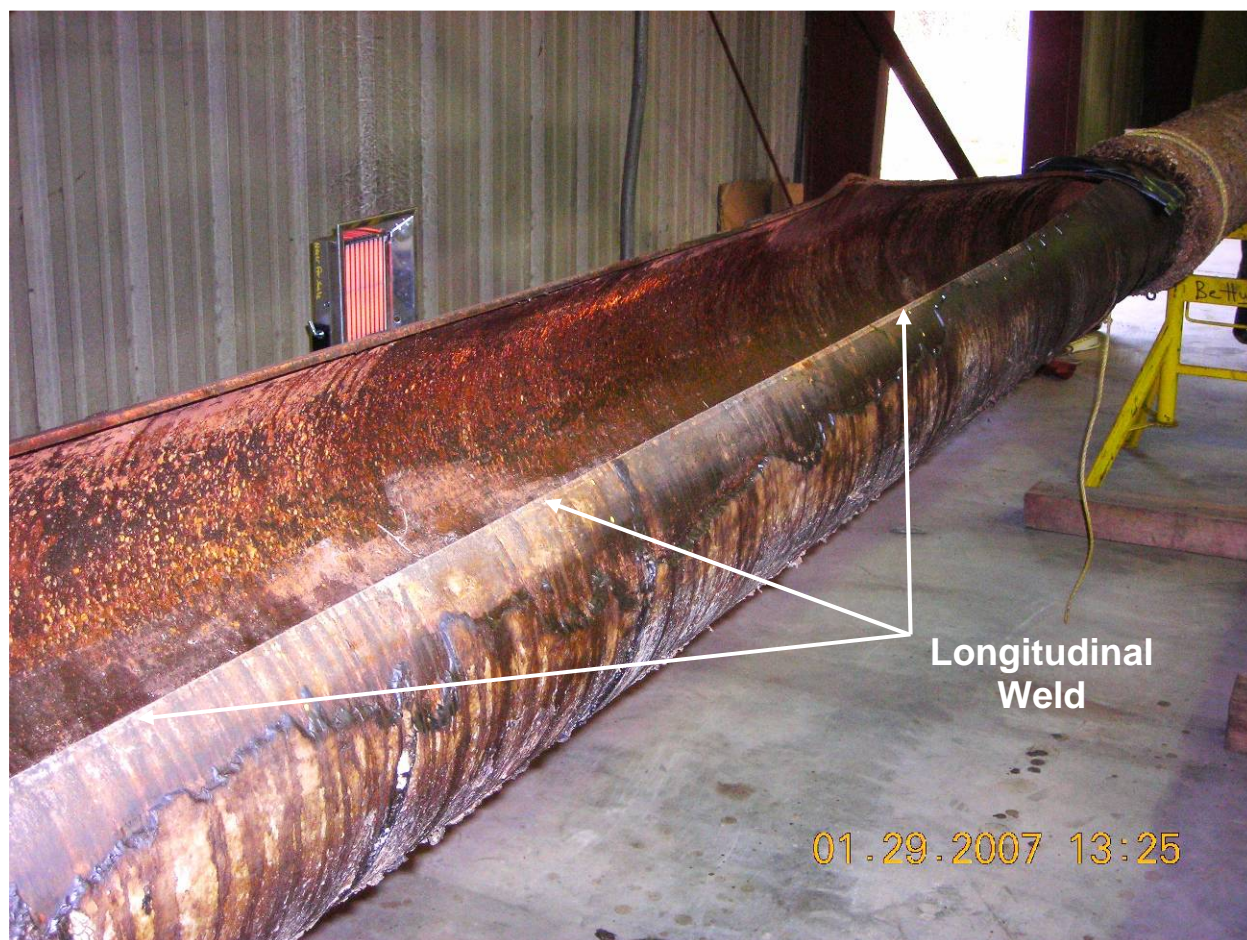
For most of its length, the longitudinal fracture followed the longitudinal pipe weld in the east portion of the sales gas line (Figure 12). The fracture did not follow the longitudinal pipe weld after it crossed the field girth weld that was located near the east end of the fracture and shown in Figure 7. The longitudinal welds were not aligned on either side of the field girth weld.

**Figure 12:** Part of the longitudinal fracture in the east portion of the sales gas line. Notice that the fracture followed the longitudinal pipe weld.

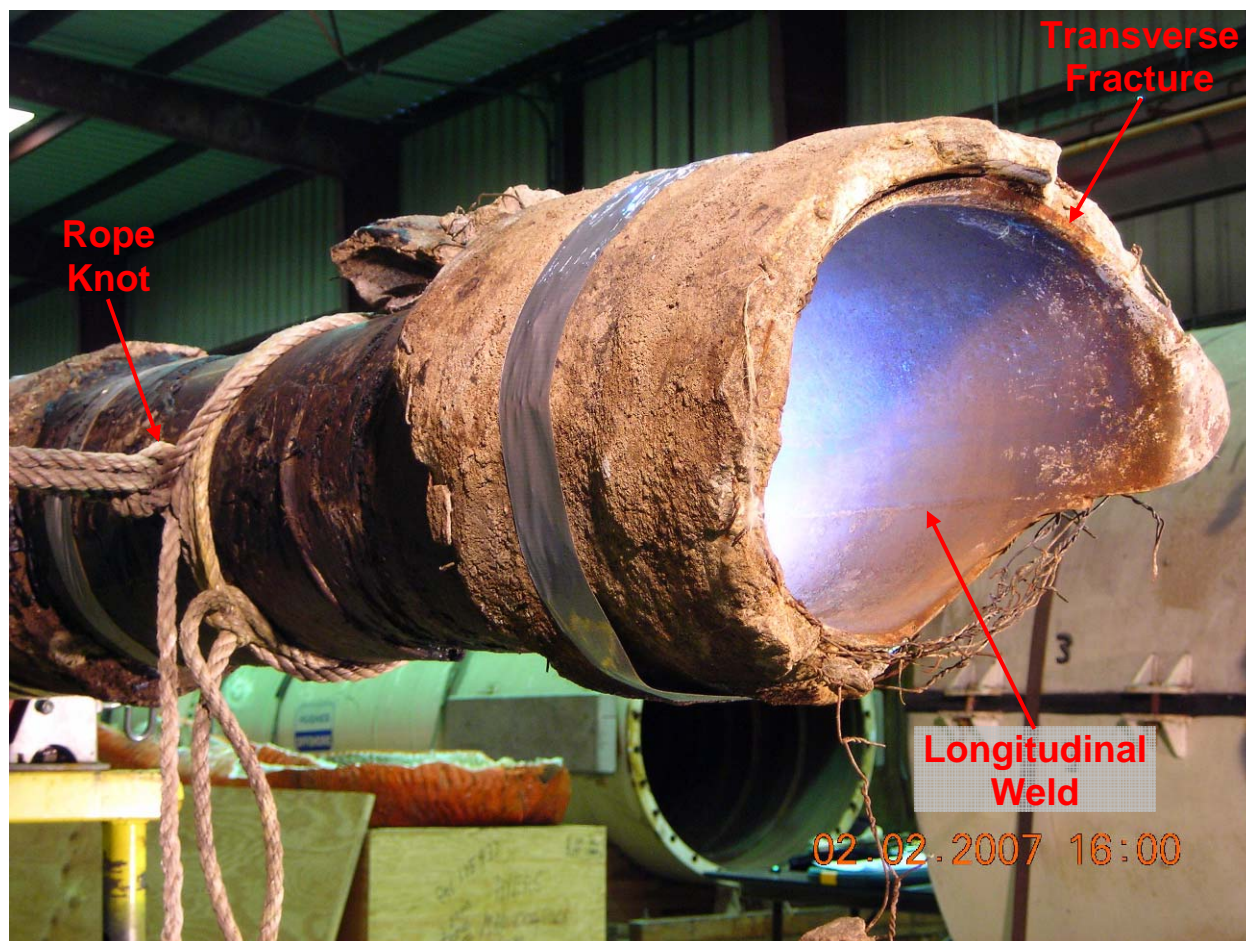
Figure 13 shows the east end of the west portion of the sales gas line at the transverse fracture. It shows the position of the longitudinal pipe weld in relation to the geometric top of the pipe as it was found following the rupture. This longitudinal weld was located near the geometric bottom of the pipe as it was found after the rupture. The longitudinal fracture did not continue past the transverse fracture into the west portion of the sales gas line. A longitudinal band of minor corrosion, similar to that observed in the east portion, was also observed inside the west portion. The band of minor corrosion is the most likely indicator of the geometric bottom of the pipe prior to the rupture. Figure 14 shows the band of minor corrosion and the location of the longitudinal pipe weld in relation to the band of corrosion. When similar features on the transverse fracture surfaces of the east and west portions of the sales gas line were aligned, the positions of the longitudinal pipe welds and bands of minor corrosion and pitting also aligned. The discrepancy between the positions of the geometric bottom of the pipe, as indicated by the rope knot versus the band of minor internal corrosion, suggests that the pipe rotated slightly during the rupture.

**Figure 13:** The east end of the west portion of the sales gas line showing the location of the longitudinal pipe weld with respect to the rope knot indicating the geometric top of the pipe as it was found after the rupture. Notice that the longitudinal weld is not fractured.

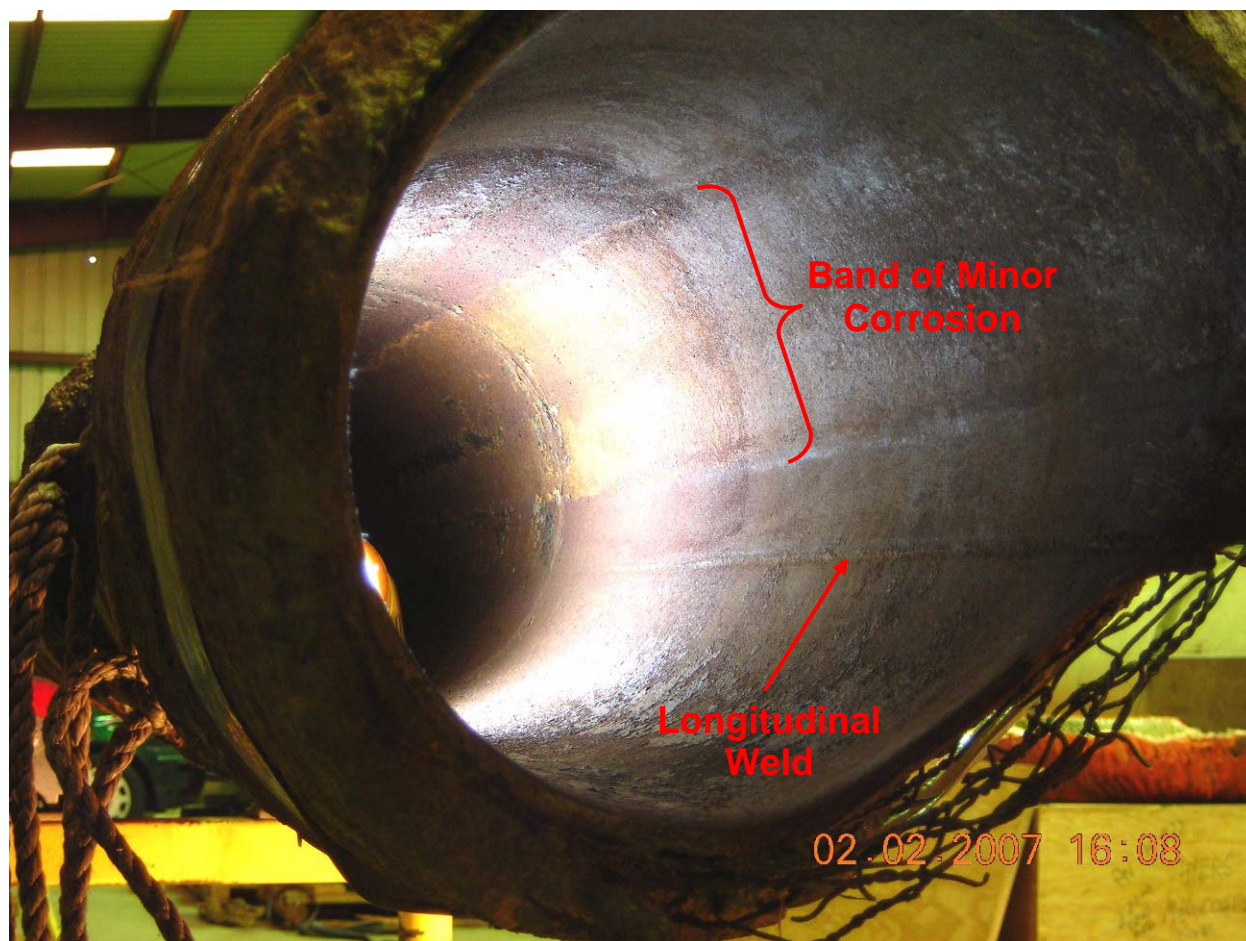
**Figure 14:** The east end of the west portion of the sales gas line showing the location of a longitudinal band of minor corrosion indicating the most likely position of the geometric bottom of the pipe prior to the rupture and the location of the longitudinal pipe weld.

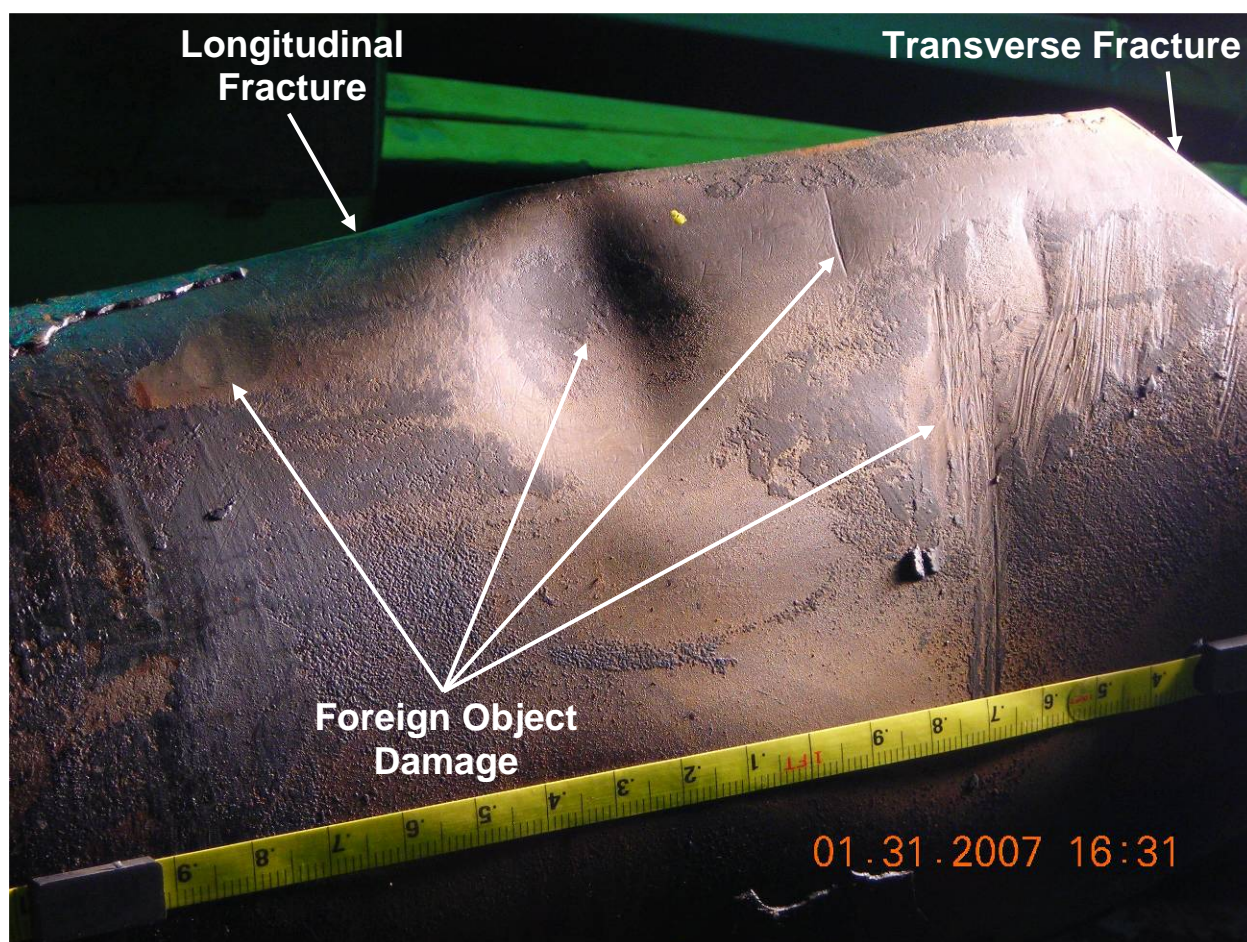
A variety of features consistent with foreign object damage were observed on both portions of the sales gas line. Figure 15 shows several substantial dents, scratches, and gouges located near

the transverse fracture in the east portion. Figure 16 shows a line of abrasions in the field weld joint closest to the transverse fracture in the west portion. The wire-reinforced concrete coating at the transverse fracture in the west portion was significantly damaged (Figures 17 and 18). The wall of the pipe was deformed inward (flattened) in the location of the damaged concrete (Figure 19). The inside diameter of the pipe was measured in this location and was found to be 7.848 inches in line with the flattened side versus 8.250 inches at right angles to this measurement, a difference of 0.402 inch. With the longitudinal welds at the transverse fracture in the east and west portions aligned, the abrasions, concrete damage, and flattening damage to the west portion aligned with the dents, gouges, and scratches on the east portion (Figure 15).

**Figure 15:** Foreign object damage located on the outside surface of the west end of the east portion of the sales gas line adjacent to the transverse and longitudinal fractures.

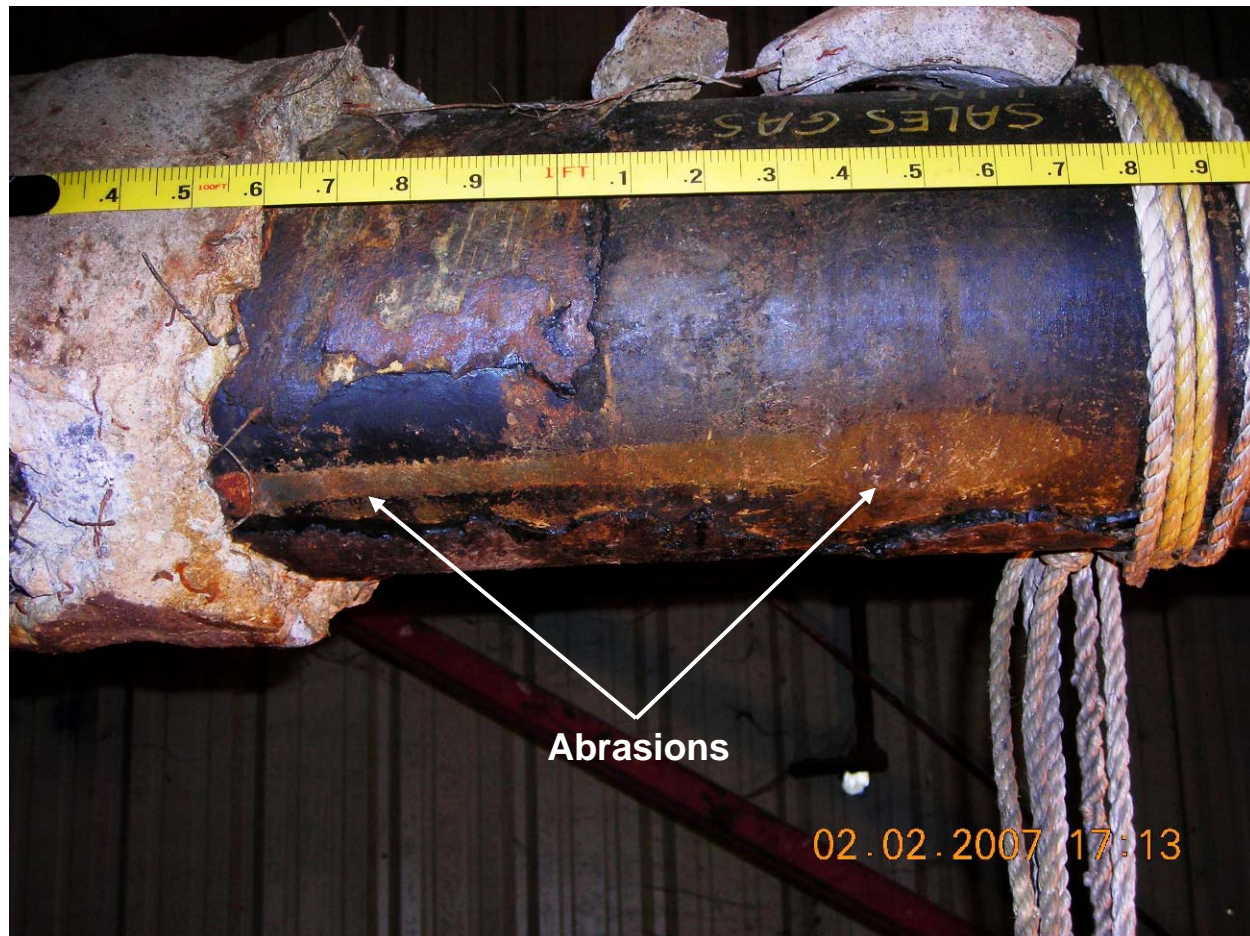
**Figure 16:** Abrasions in the field weld joint closest to the transverse fracture in the west portion of the sales gas line.

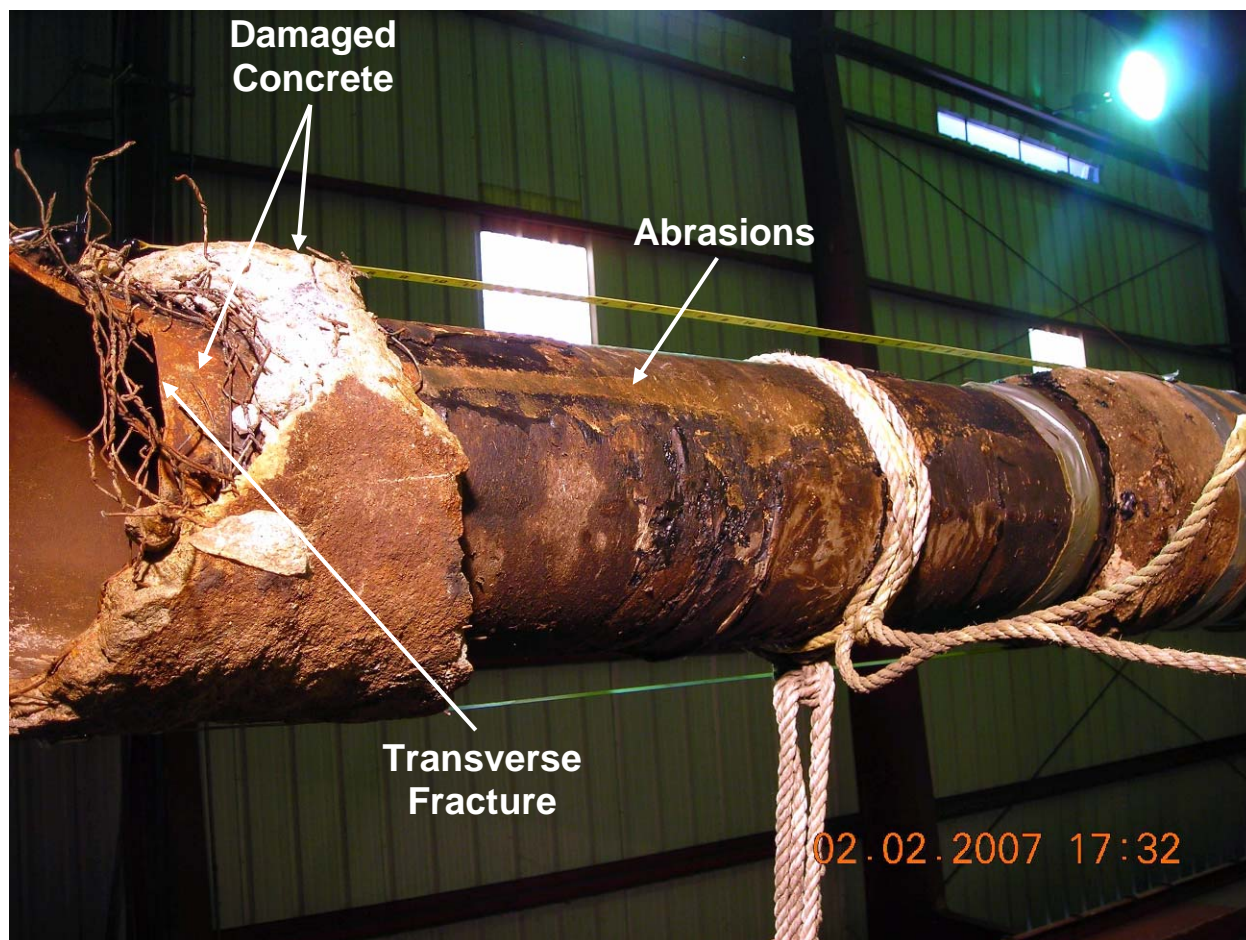
**Figure 17:** The east end of the west portion of the sales gas line showing damaged, wire-reinforced concrete adjacent to the transverse fracture.

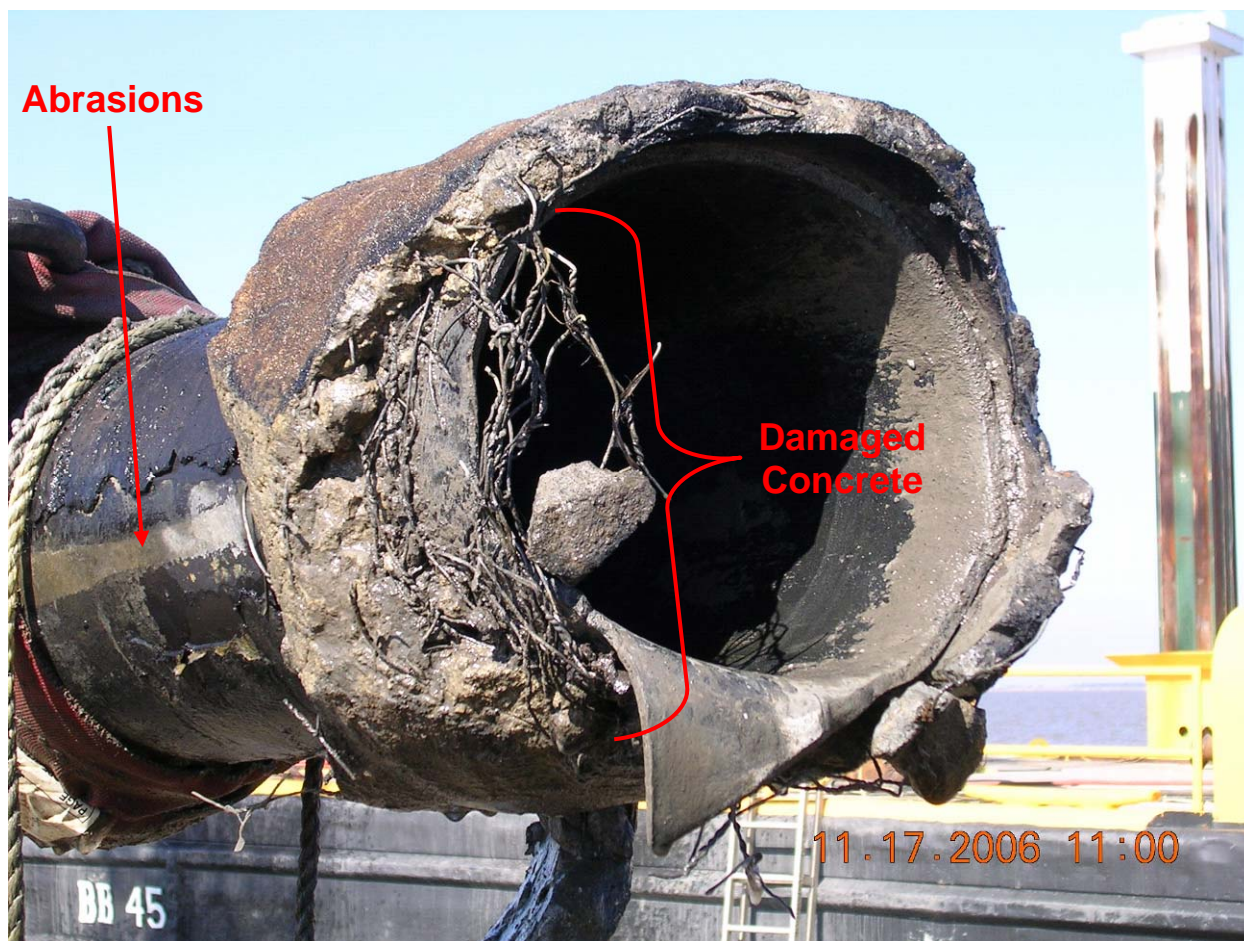
**Figure 18:** Abrasions in the field weld joint and substantial damage to the wire-reinforced concrete at the transverse fractured end of the west portion of the sales gas line. The photograph was taken during salvaging of the pipe.

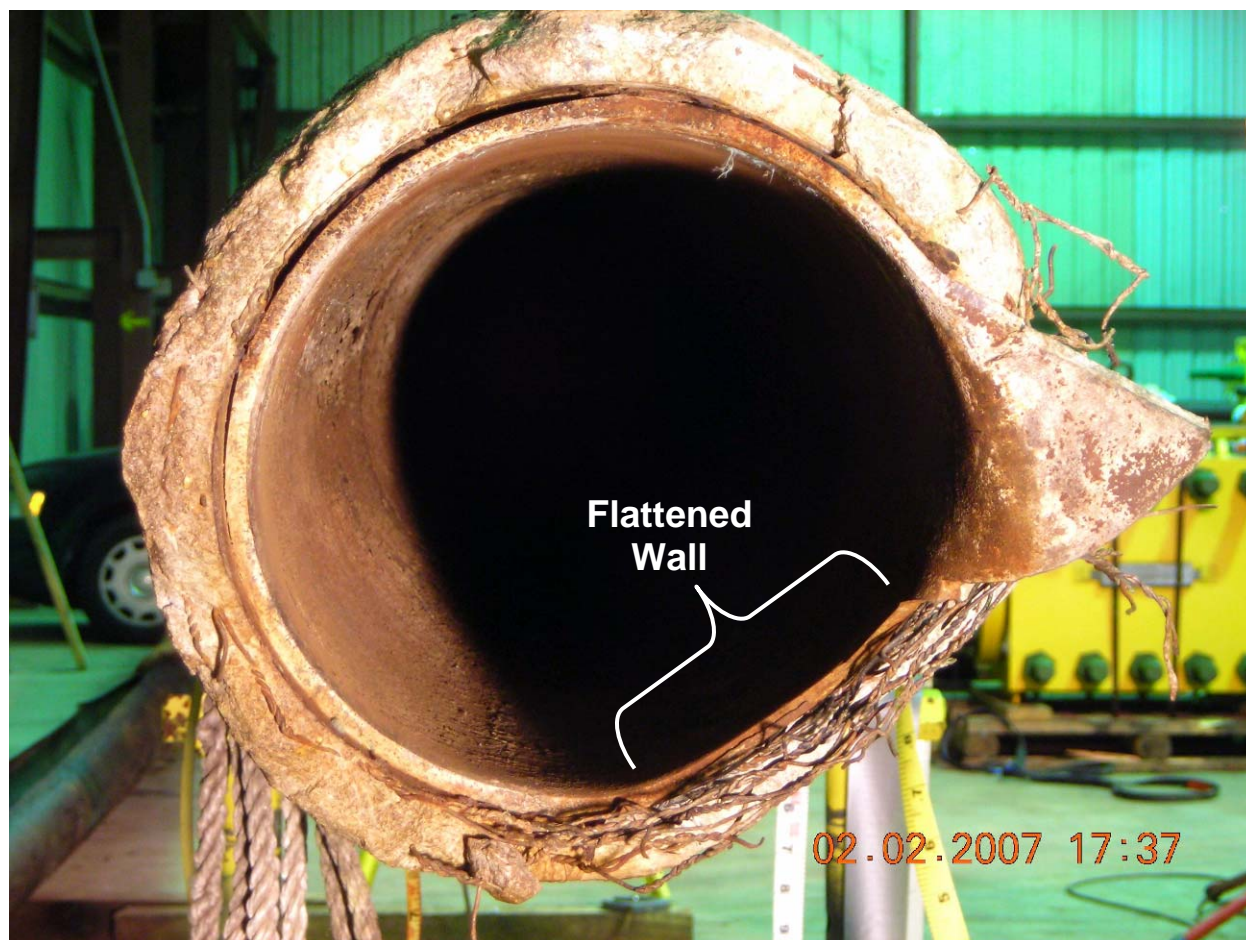
**Figure 19:** The transverse-fractured end of the west portion of the sales gas line showing inward deformation (flattening) of the pipe wall in the same location as the damaged concrete.

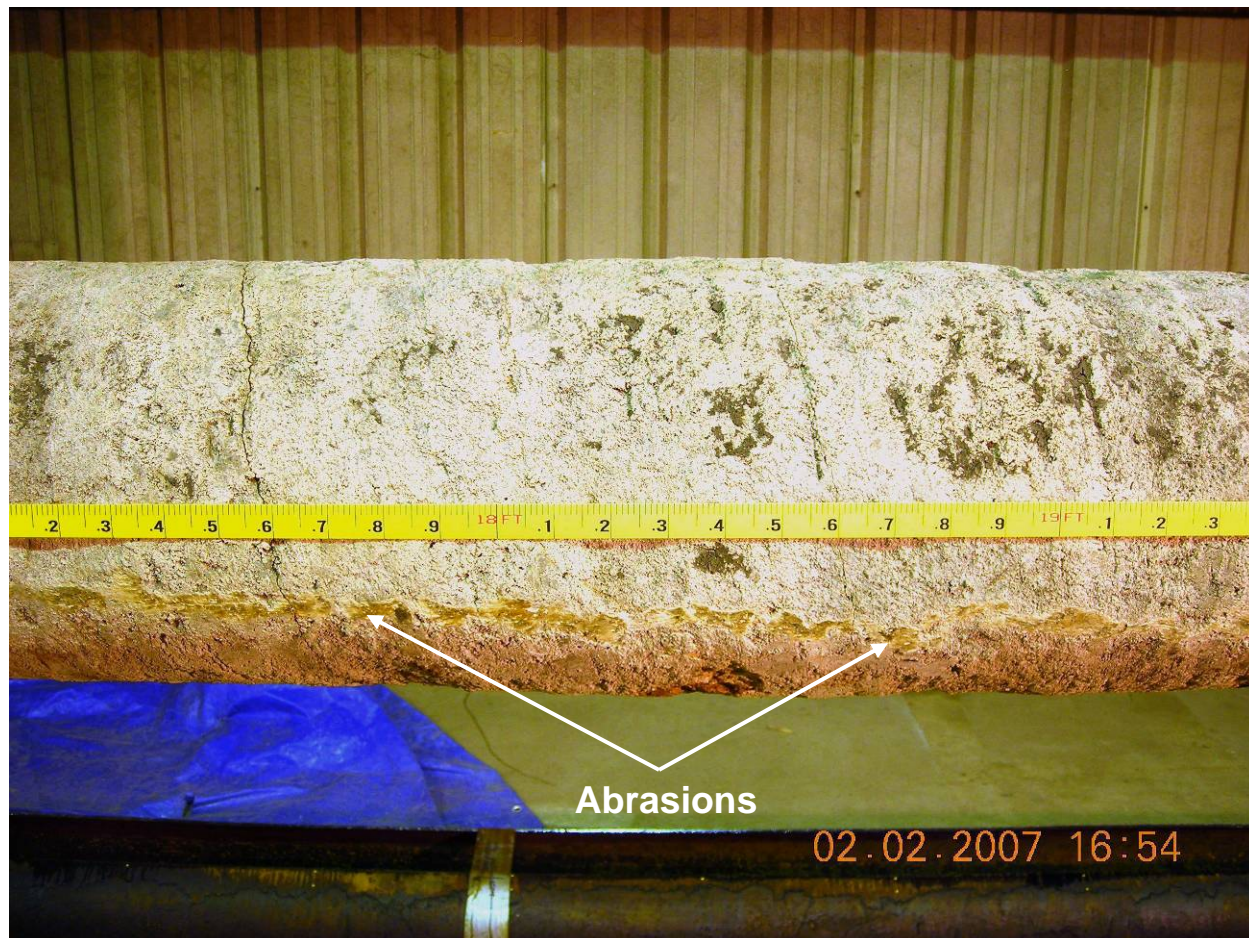
The concrete coating on the west portion exhibited additional features that could have been pre-existing conditions or foreign object damage. They included lines of abrasions on different sides of the pipe (Figure 20), cracks, and spalls (Figures 21 to 23).

**Figure 20:** Abrasions along the outside surface of the concrete coating on the west portion of the sales gas line.

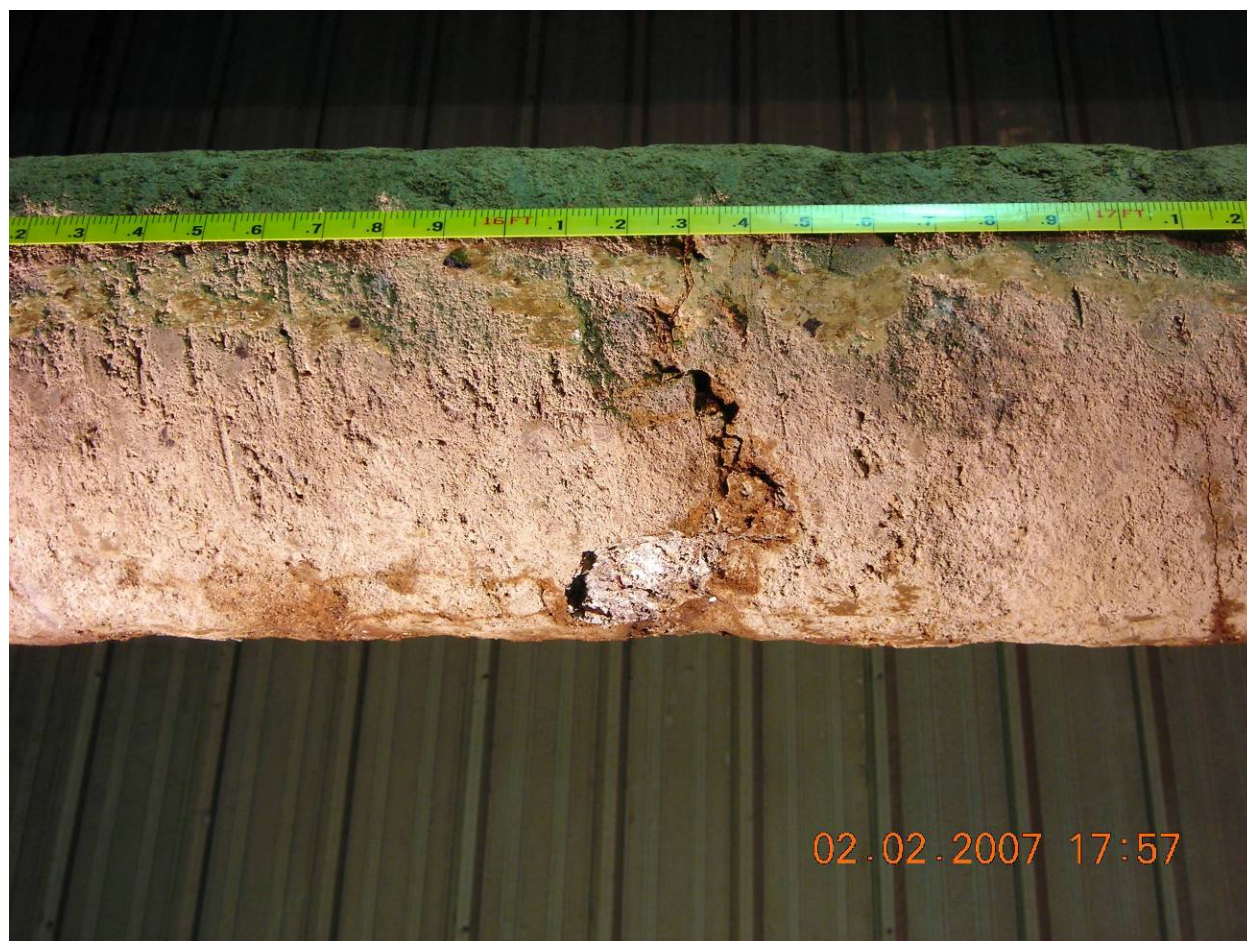
**Figure 21:** Cracked and spalled concrete coating located approximately 16.2 feet from the transverse fracture in the west portion of the sales gas line.
